MARINE SAFETY ADVISORY No. 21-17

Subject: EMERGENCY ESCAPE BREATHING DEVICE – PRODUCT RECALL

SAFETY BULLETIN 09 - EMERGENCY ESCAPE BREATHING DEVICE - PRODUCT RECALL

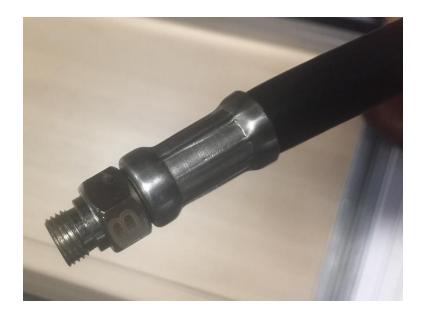
The MCA has been made aware of potential concerns over the Hwayan EEBD (TH15B) regarding the ability to deliver sufficient breathing air to the wearer. After various tests, the results highlight that units within the affected lots have an inherent blockage which is likely to be attributed to manufacturing discrepancies.

The blockage is observed in the pressure reducer connector which attaches to the air bottle as seen in the image below.

Testing results further show that the affected units do not fulfil the required delivery rate of air, even once the blockage has been cleared with a fine pin or needle head. The required airflow rate is specified in the Hwayan Instruction manual as 38+/-2 l/min.

Ship operators should check the EEBDs they have on board. If an affected unit(s) are held, the operator should immediately contact the manufacturer for a replacement unit at no further cost.
