No.: 032/2016

Subject: TALON II Lifeboat On Load Release Systems – Incorrect Indicator marking for release handle

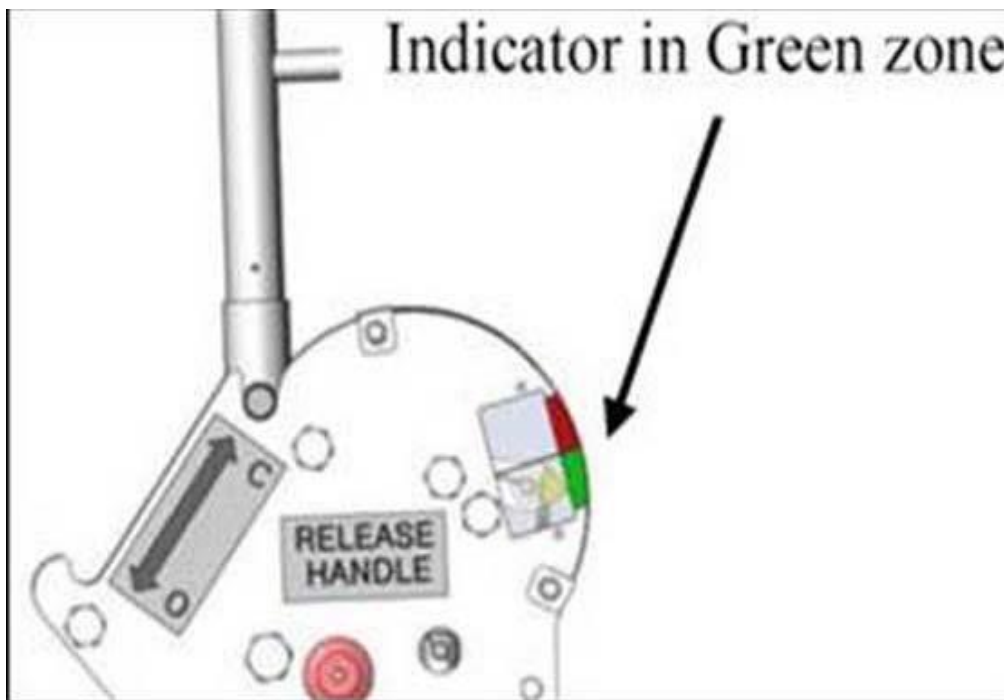
Picture 1 – As per Makers Manual

- The Bahamas Maritime Authority has issued Technical Alert No. 16-38 (copy attached) highlighting a manufacturing defect identified on one of Hyundai Lifeboat “TALON II 4.0” on load release hooks.
- It was noted that the position indicator markings for the hydrostatic interlock were incorrectly marked with the red and green sectors being reversed as shown in below pictures.

- In view of above, ship owners/ managers and masters are advised :
 - To inspect the hydrostatic interlock position indicator markings on the release mechanisms installed on their lifeboats and especially lifeboats fitted with Hyundai TALON II 4.0 or 9.0 on load release hooks, to ensure that they are correctly marked as per the manufacturer’s instructions.

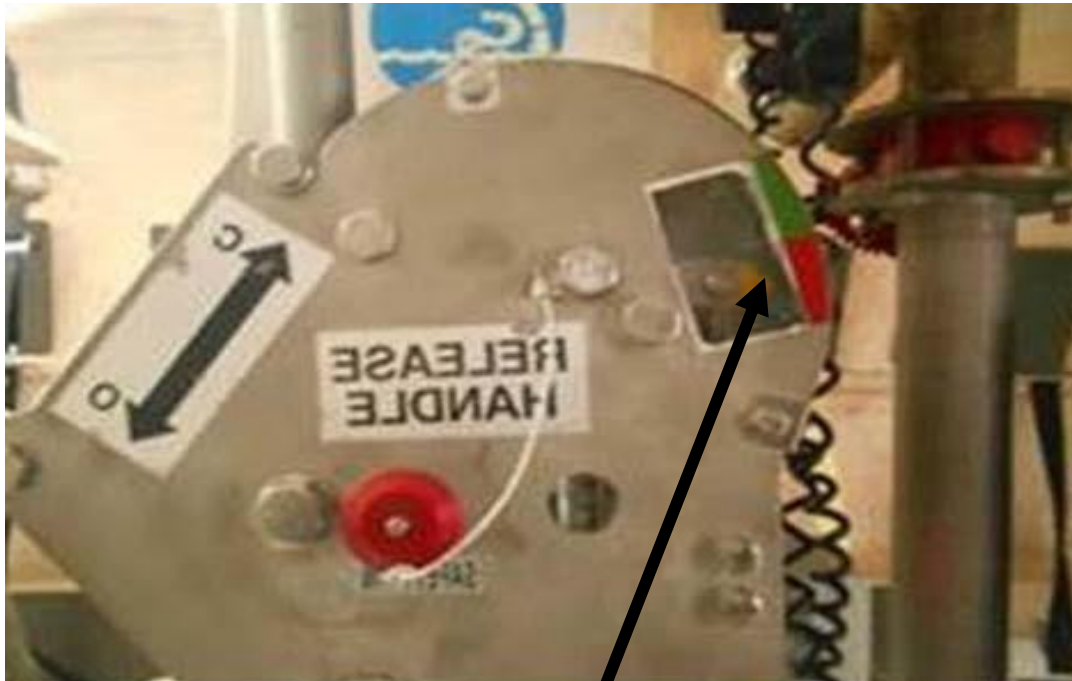
Picture 2 – As found on board

Position indicator reversed

- The LSA code states “If colour coding is used, green shall indicate a properly reset hook and red shall indicate danger of improper or incorrect setting”. In this case the improper marking could potentially have led to improper resetting or operation of the on load release system.

- Investigation by the Bahamas Maritime Authority in consultation with the ship owners, type approval body and manufacturer, has identified that the incorrect marking of the interlock position indicator markings occurred during manufacturer of the on load release system.

- Where markings are found to be incorrect, the Classification Society issuing the ships statutory certification and the Flag Administration are advised. The manufacturers are also to be contacted in order to arrange for the defect to be rectified.
- To ensure that clear operating instructions as required by paragraph 4.4.7.6.11 of the LSA Code are provided within the lifeboats for the actual on load release systems installed on the lifeboat.
