MARINE SAFETY ALERT

Safety Alert 17-16

MAN B&W Cooling Jacket Failures **Using the correct bolts is essential!**

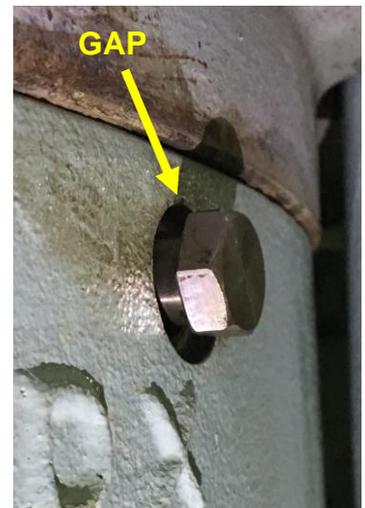
By design, the shoulders of these bolts are longer than the cooling jacket wall thickness. New replacement bolts will often have even longer shoulders. When the bolts are properly tightened there will likely be a gap between the bottom of the bolt head and the outside of the jacket cover. (Image A) The extra shoulder length allows the cooling jacket to position itself concentrically on the bottom of the cylinder cover and facilitate any movement or slight expansion of the o-rings. It also allows for some expansion of the cast iron cooling jacket. If the cooling jacket is slightly positioned non-concentrically on the cylinder cover, some of the bolt head's bottom surface areas may appear as if the bolt is fully tightened against the outside of the jacket cover.

Image A: Properly secured cooling jacket bolt.

- Owners, managers and operators ensure that their vessel engineering staffs have access to all available manufacturer service letters for propulsion, electrical generation, steering and other critical equipment; and
- Senior engineering personnel on vessels with MAN B&W MC-C and other similarly constructed engines using the same cooling jacket cover securing method *review* the applicable maintenance procedures and ensure that persons assembling these components know that the shoulder bolts may not butt up against the cooling jacket cover, as breakage may occur if forced, and that regular bolts with no shoulders should never be used.

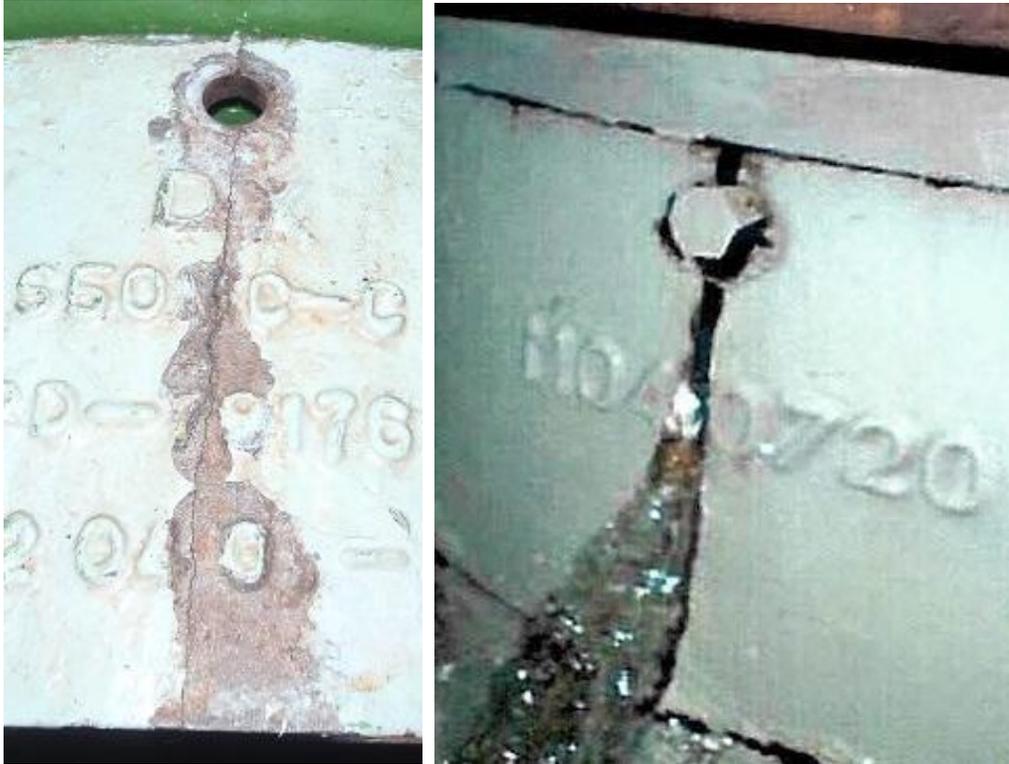
In the past, cooling jackets have fractured vertically through the bolt holes that secure the jackets to the cylinder cover. (Photographs - next page.) These fractures have caused a loss and reduction in cooling water that eventually resulted in the overheating of the cylinder cover. That then caused an automated slow-down of the engine and reduced the ship's maneuverability. These fractures can be caused by the following:

- Stress corrosion cracking
- Inadequate coolant water treatment
- Excessive rust and scale development
- Use of wrong bolts to secure cooling jacket
- Blockages of coolant flow throughout jacket space and cylinder cover passages
- Overheating / thermal expansion of cylinder cover causing excessive stress on jacket cover

Photographic examples of fractures:
