# Republic of the Marshall Islands

### MARINE SAFETY ADVISORY No. 12-18

**Subject: QUALITY ISSUE IN COSMO MED AND TYPE-APPROVED FIRE DOORS  
– FAULTY A-60, A-0, AND B-0 FIRE DOORS**

**Date: 20 April 2018**

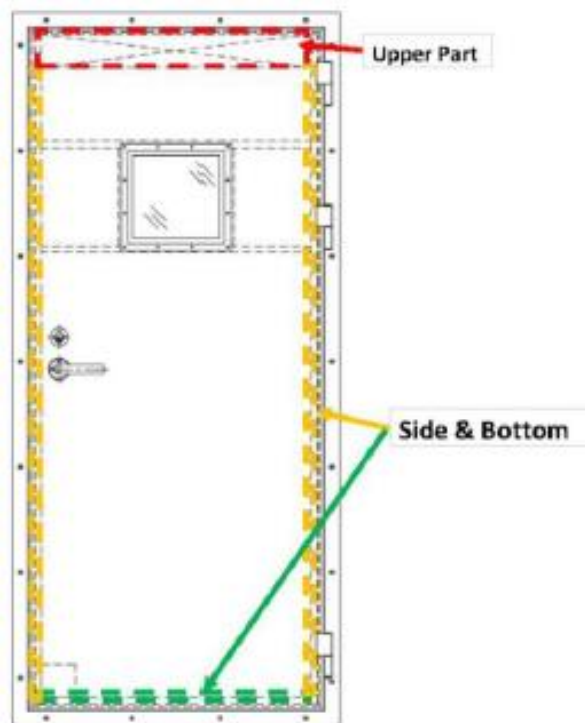
Figure 1

A quality issue has been discovered in fire doors manufactured by COSMO Co., Ltd, where insulation has been found to be partly missing from the upper part, sides, and bottom of the doors (See Figure 1). Fire doors manufactured by COSMO and matching the following criteria may be affected:

1. A-60, A-0, and B-15 class fire doors;
2. certified to MED Modules B and D, type-approved and certified by DNV-GL; and
3. produced between November 2013 and July 2017.

Subsequent testing and analysis has confirmed that the affected A-0 and B-15 doors meet the requirements as set out in part 3 of the International Maritime Organization (IMO) 2010 International Code for Application of Fire Test Procedures (2010 FTP Code), and these doors may remain in service as-is.

However, the affected A-60 rated doors require an on-board repair in order to assure that these A-60 doors meet the requirements of the IMO 2010 FTP Code. The Republic of the Marshall Islands (RMI) Maritime Administrator (the “Administrator”) highly recommends that owners and operators with the aforementioned doors check them to determine whether they are affected by the quality issue. COSMO has devised a test which does not require the removal of the doors:

The procedure for the permanent repair of these affected A-60 fire doors is summarized below:

- An approved type of non-combustible material must be injected into the top part of the door through the hole in order to fill the empty space left by the missing insulation.

- The repair work should be carried out by an experienced general outfitter, or by someone who is familiar with drilling and hole cutting. The work must be in accordance with COSMO repair procedure CD-RP-01, Rev. 8.

- After the repair work has been completed, a repair work report, Form COSMO 90, should be documented and sent to COSMO, who will verify it by their responsible person to confirm guarantee of the repaired doors.

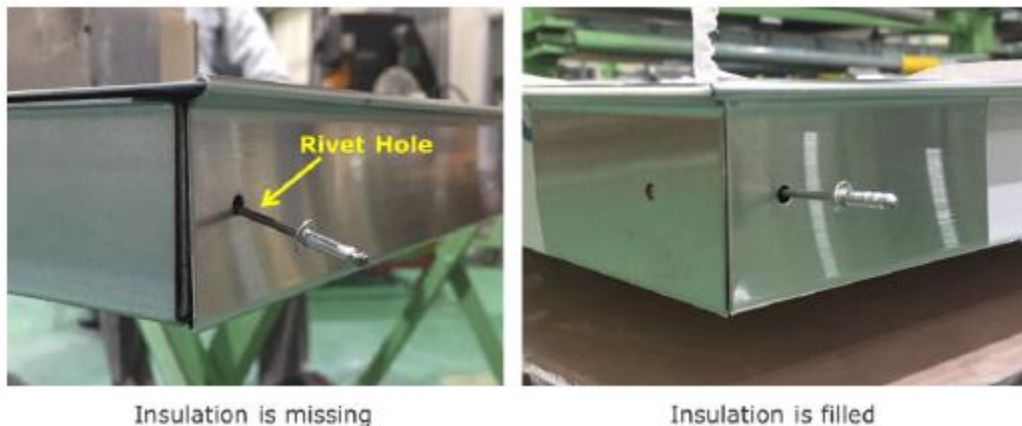
Figure 2

1. Remove a rivet or hinge bolt on the side of the door.
2. Insert a metal pin through this rivet/bolt hole, and check for insulation.
3. If a door is found to be missing insulation, please inform COSMO at:

COSMO has established a repair procedure, CD-RP-01, Rev. 8, to address this issue, available from them either by telephone (+82 51 519 9900) or by email at [cosmoqm@bn-cosmo.com](mailto:cosmoqm@bn-cosmo.com).
