Final report MO-2017-205: Multipurpose container vessel *Kokopo Chief*,
cargo hold fire, 23 September 2017

Marine inquiry MO-2017-205
Multipurpose container vessel *Kokopo Chief*

Cargo hold fire

23 September 2017

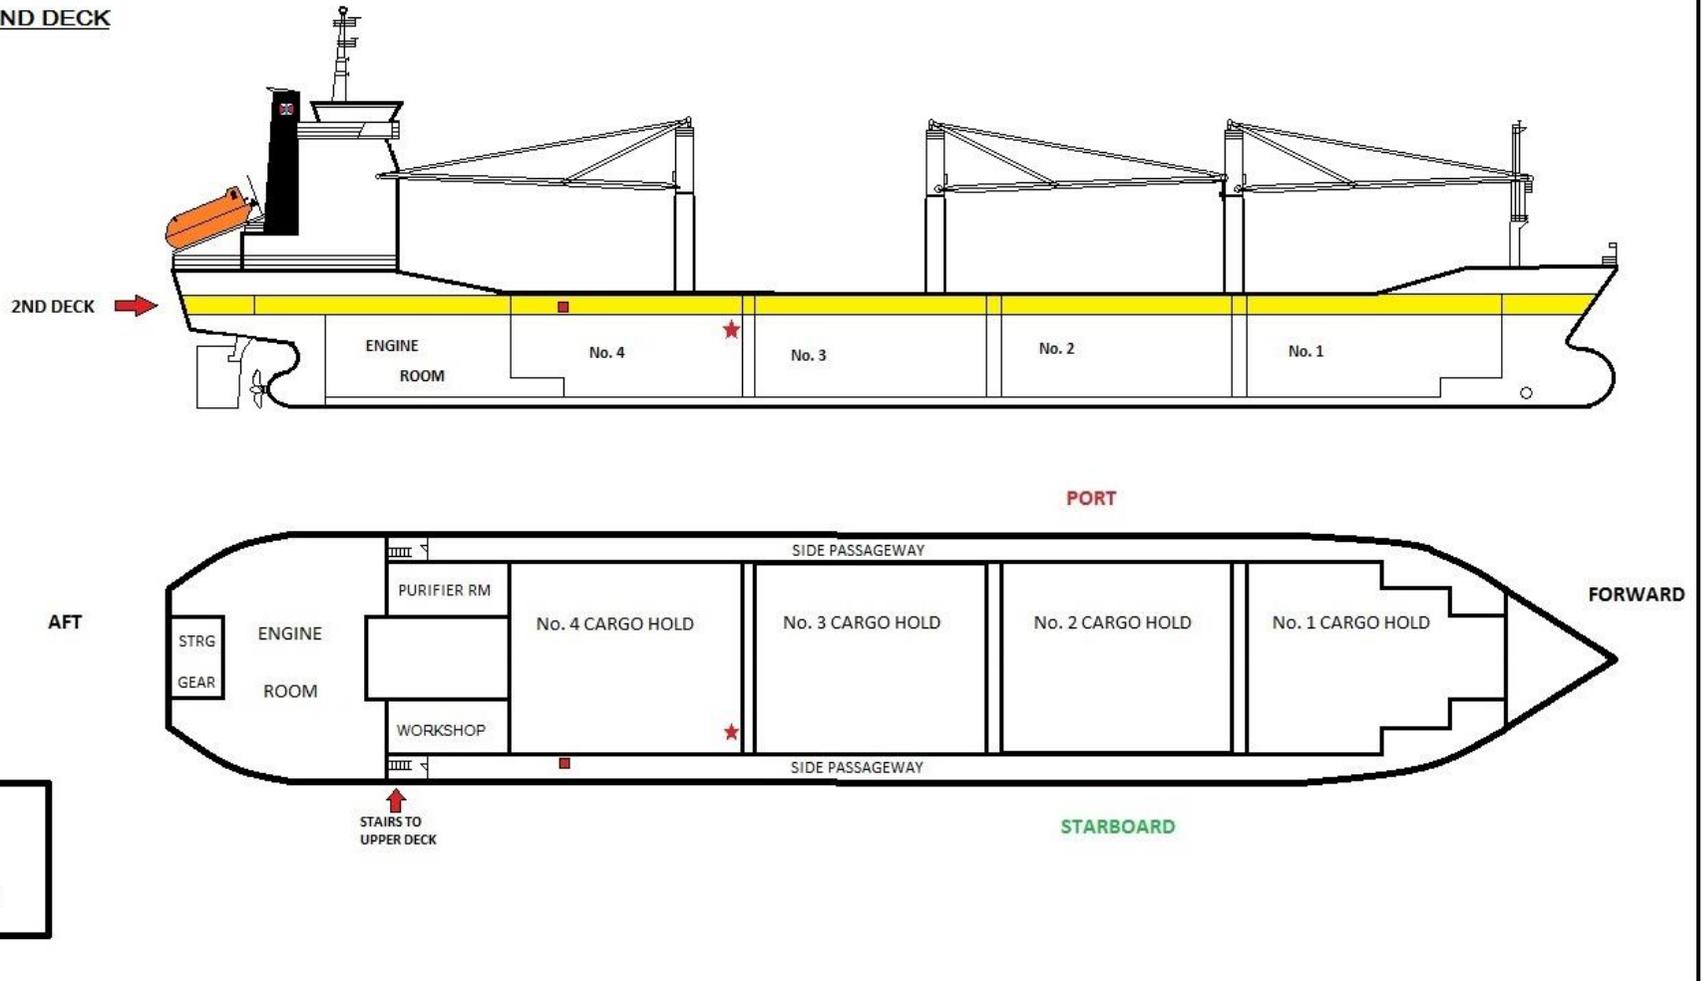
Figure 1
Location of fire and access hatch

- 3.2.8. The chief officer and the fourth officer went to the starboard-side under-deck passageway, where there was an access hatch to number 4 cargo hold (see Figure 1). They lifted the lid of the access hatch and smelled burning, so immediately closed the lid. They reported to the bridge that there was a fire and that it was not a false alarm.

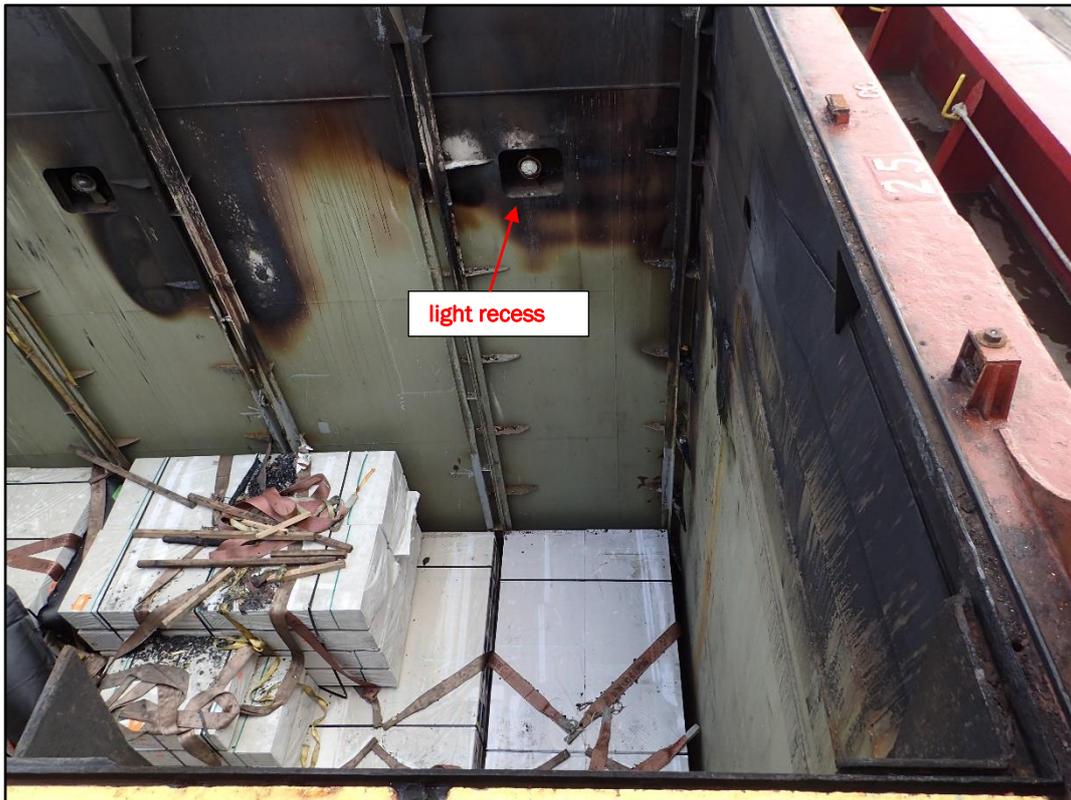
Figure 2
Remaining timber stowed in number 4 cargo hold after damaged timber had been removed

- 3.3.1. The timber loaded into number 4 cargo hold consisted of 43 packs of sawn radiata pine¹². The timber packs at the origin of the fire contained individually wrapped, kiln-dried, H4¹³ treated posts, 90 millimetres (mm) by 90mm. Each pack had an outer wrapping of woven plastic sheeting.
- 3.3.2. Safety data sheets were reviewed for several brands of treated radiata pine. They all recommended avoiding heat and ignition sources when storing and handling treated pine and its products.
- 3.3.3. The damaged timber was removed to the extent necessary to confirm the fire was out. Figure 2 shows the state of the cargo hold once the timber packs had been removed. The worst of the smoke and heat damage on the forward bulkhead of the cargo hold indicated that the seat of the fire was in the vicinity of the recessed cargo hold light.

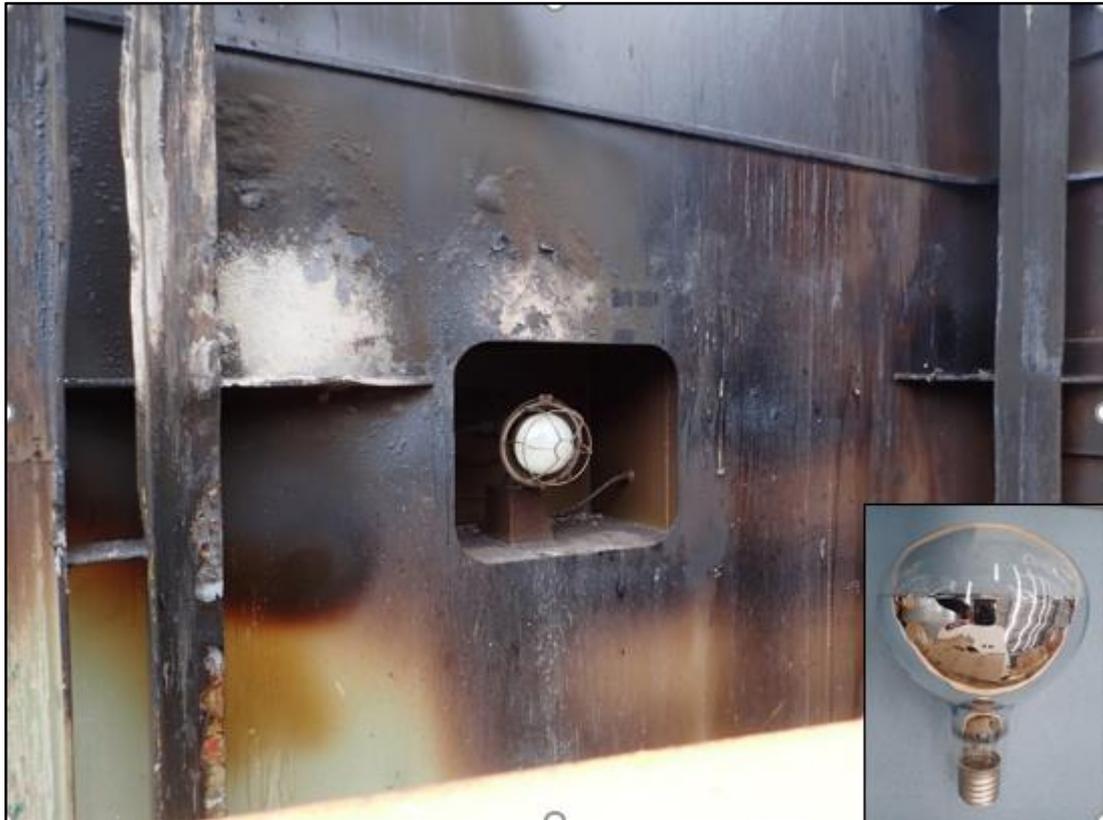
Figure 3
Cargo hold light in recess (inset, the reflector lamp)

- 3.3.4. The cargo hold lights were fitted with Matsuda 500-watt (W) reflector lamps. They were each housed in a protective cage and recessed into the cargo hold bulkhead so that they would not be damaged during cargo operations (see Figure 3).

- 3.3.5. The face of the lamp was 40 mm away from the inside of the protective cage and the protective cage was set in 5 mm from the edge of the recess.

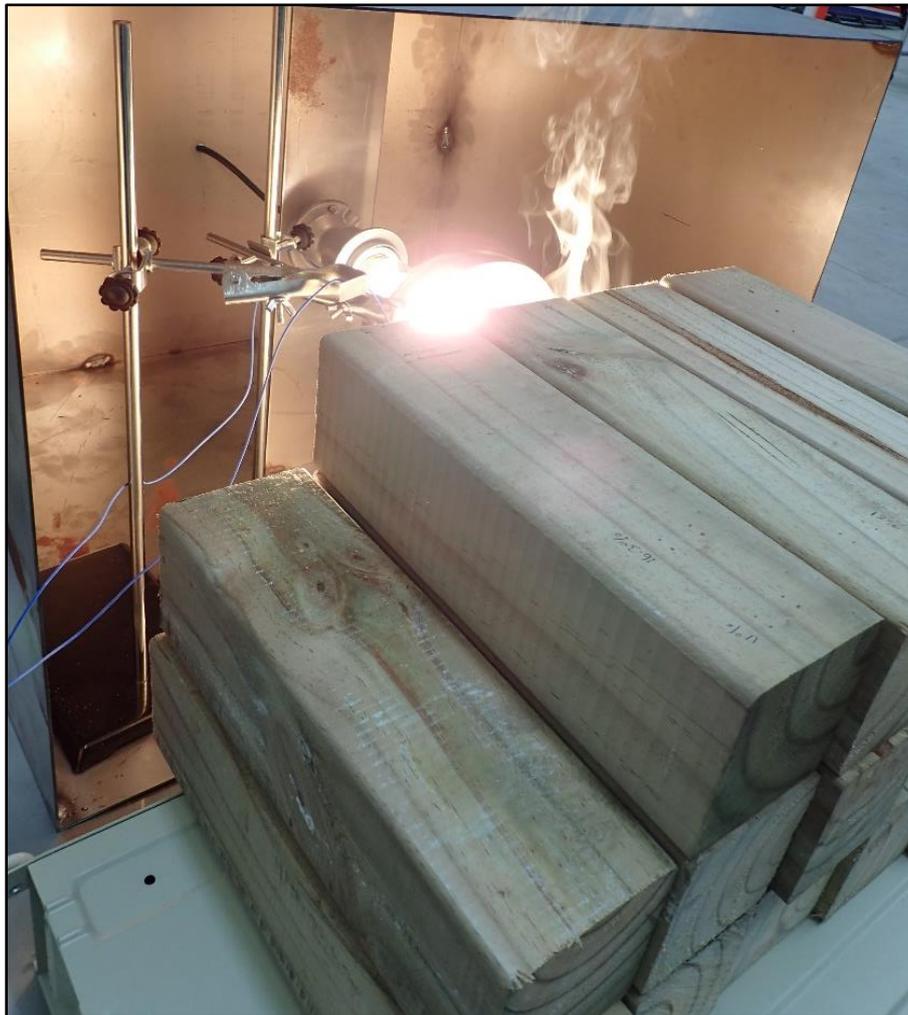
Figure 4
Lamp test set-up

- 3.3.10. Because there was no data available for a 500 W reflector lamp, the Commission carried out tests¹⁷ to measure the temperature of a Matsuda 500 W reflector lamp when operated under conditions similar to those on board. A steel box was fabricated with dimensions matching those of the light recess in the cargo hold (600 mm x 700 mm x 525 mm). Thermocouples¹⁸ were used to measure the temperatures at the centre of the lamp's face and at the surface of the timber opposite the lamp. A stack of H4 treated, dry radiata pine was placed 50 mm from the opening to the box and the lamp was switched on (see Figure 4).

- 3.3.11. Before the lamp reached a maximum temperature, the test had to be stopped because the timber had already started to smoulder¹⁹ (see Figures 4 and 5). At the time that smoke was first seen the temperature of the lamp was 155 °C (degrees Celsius) and the temperature at the surface of the timber was 114 °C. The temperature of the lamp continued to rise and was 208 °C when the test was stopped (see Figure 6).

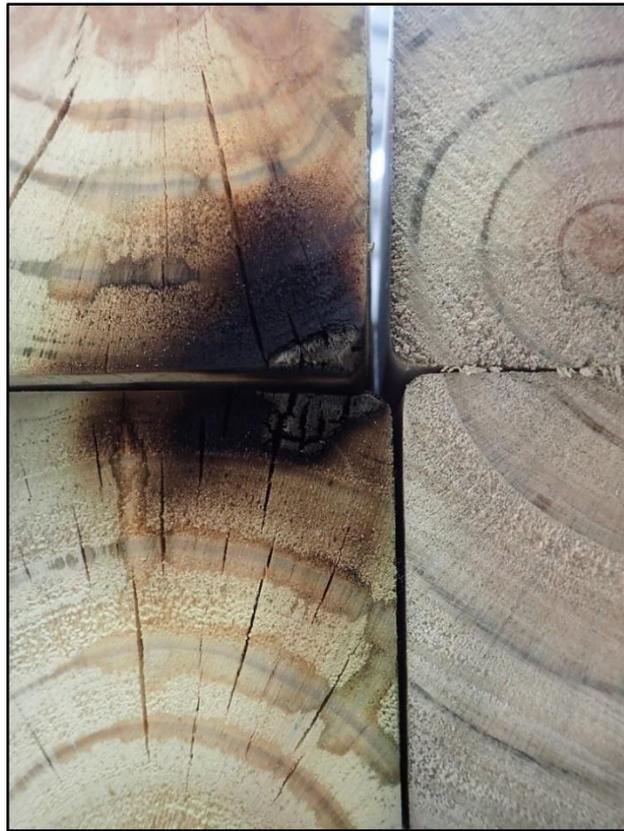
Figure 5
Photograph taken after three minutes' exposure to the lamp

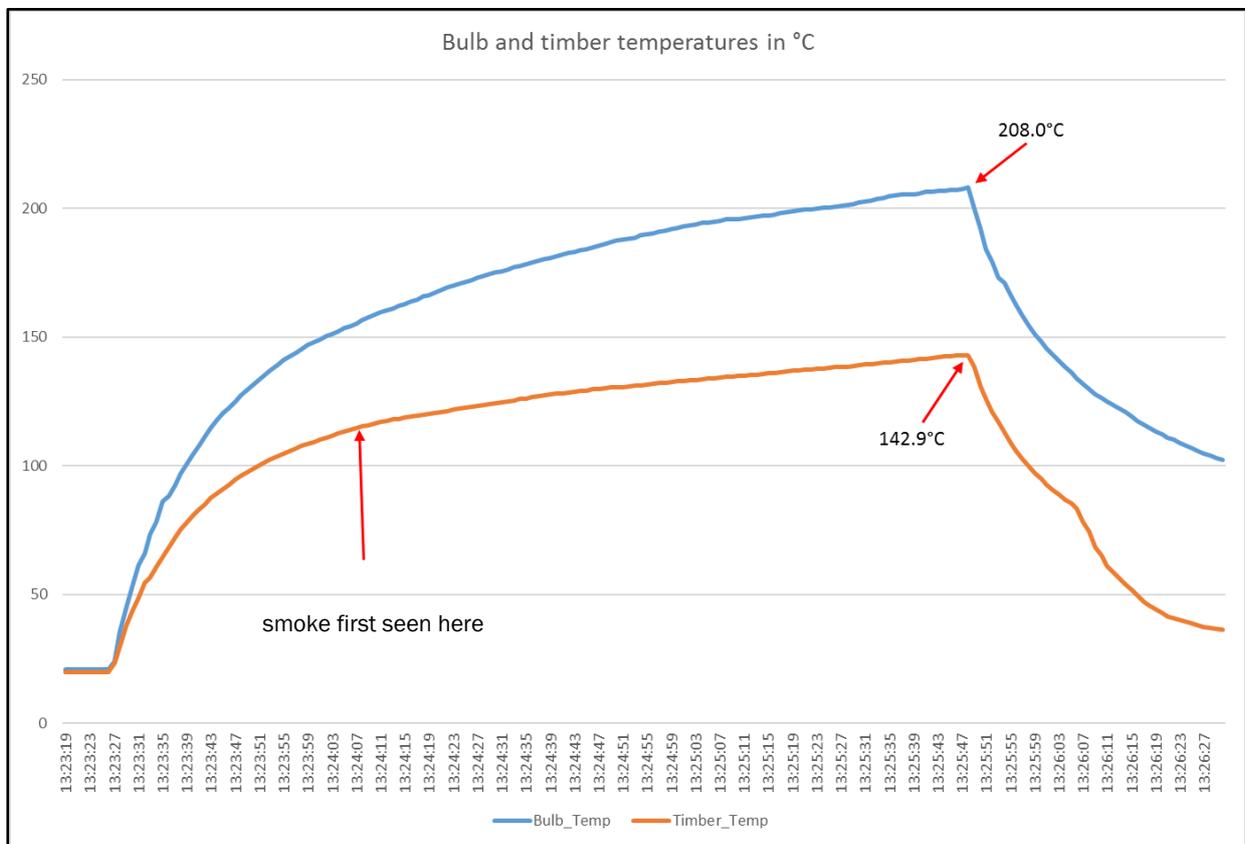
Figure 6
Graph showing temperatures recorded by test thermocouples

- 3.3.12. With no obstruction across the opening to the box, the lamp reached a maximum temperature of 191°C and remained at 188-190°C. It was found that placing the timber across the opening restricted the airflow around the lamp and prevented heat dissipation. The lamp reached a higher temperature and the heat was concentrated onto a focused point on the timber, where the smouldering commenced.

- 3.3.13. Several tests were run. However, when timber was placed at the opening to the steel box the tests had to be ceased after three to four minutes for safety reasons. Consequently, the maximum temperature the lamp would have reached could not be determined. The maximum temperature recorded was 216°C and rising.

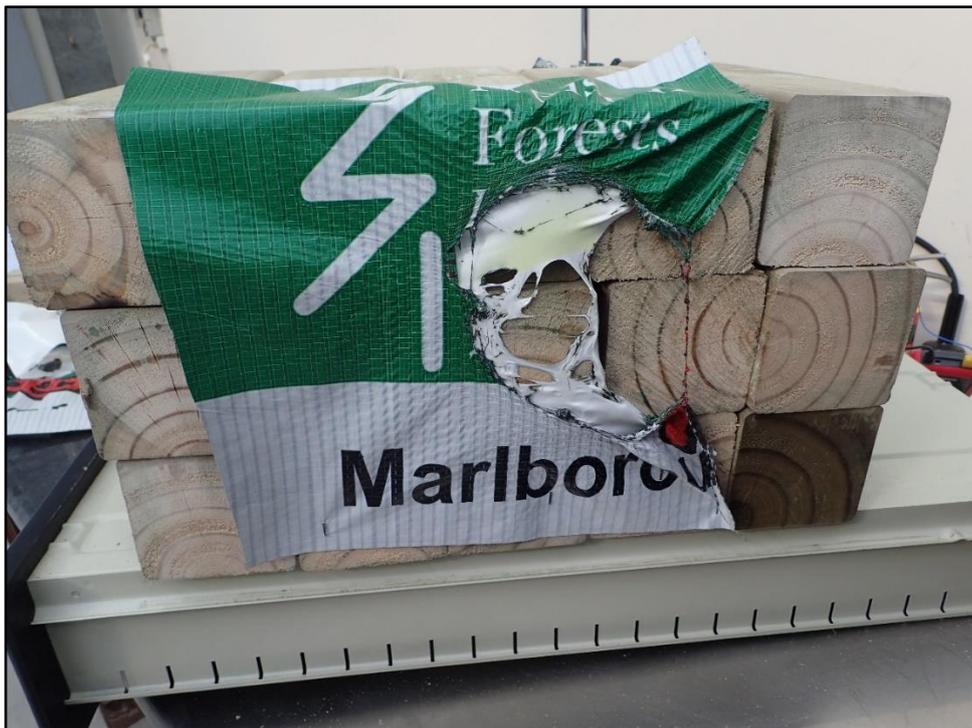
- 3.3.14. Samples of the plastic used by the sawmill²⁰ to wrap its timber products were secured over the test timber. The plastic was found to melt, but not ignite, and left the timber exposed to the hot lamp (see Figure 7). The plastic wrapping was not considered an accelerant. In fact, in the tests the wrapping delayed the start of the timber combustion for about 30 seconds.

Figure 7
Plastic wrapping after two minutes, 20 seconds of exposure to the ship's lamp

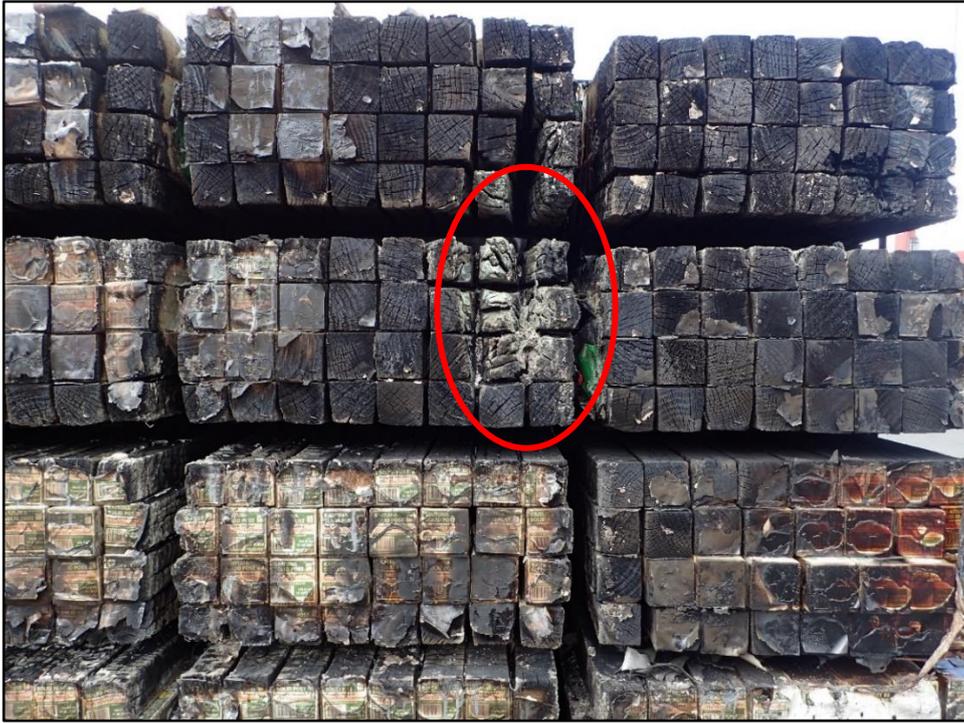
- 4.2.1. The burn pattern on the timber cargo adjacent to the cargo hold light was a strong indication that the heat generated by the reflector lamp was the cause of the fire. The only other potential sources of heat found in the cargo hold were two old cigarette butts found in the hold. However, both were found at the opposite end of the hold to the fire location. One had been well stubbed out and the other had been discarded behind a cell guide²¹ and could not have come into contact with any cargo.

- 4.2.4. The deep scorching of the timber that was stowed directly opposite the 500 W lamp showed that enough heat was radiated from the light to melt the plastic wrapping and cause the exposed timber to smoulder (see Figures 9 and 10). This timber was estimated to have been loaded as close as 45-50 mm from the face of the lamp. Over time the plastic wrap melted to expose the timber ends, which became hot enough to start a smouldering fire.

Figure 9
Timber packet showing origin of fire

- 4.2.8. Another measure that can be taken to mitigate the risk of similar fires is having procedures in place for ensuring that cargo hold lighting systems are turned off (and, if necessary, isolated) at an appropriate time before a loading operation creates the hazard. In this case, the lights could have been switched off and/or isolated as soon as the timber packs were placed over the lighting recess.

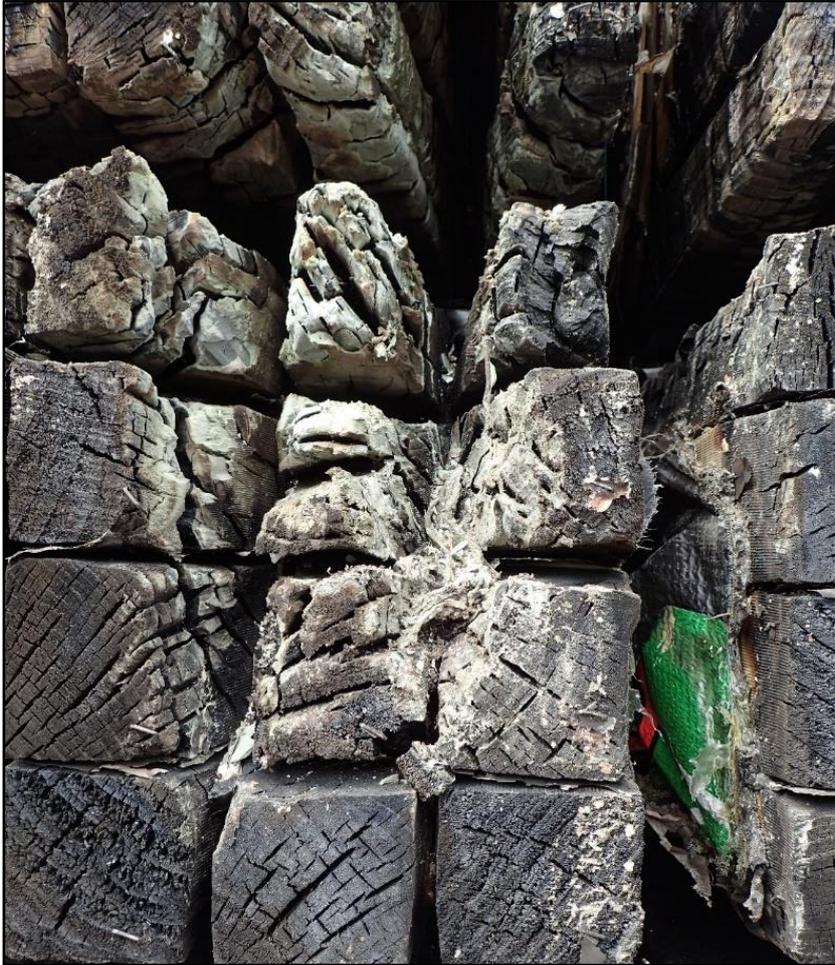
Figure 10
Charred timber at origin of fire

- 5.1. The fire was caused by heat radiating from an incandescent cargo hold lamp that set fire to packs of timber that had been stowed within 45-50 mm of the lamp.
