# SAFETY BULLETIN

## Safety at Survey Sites

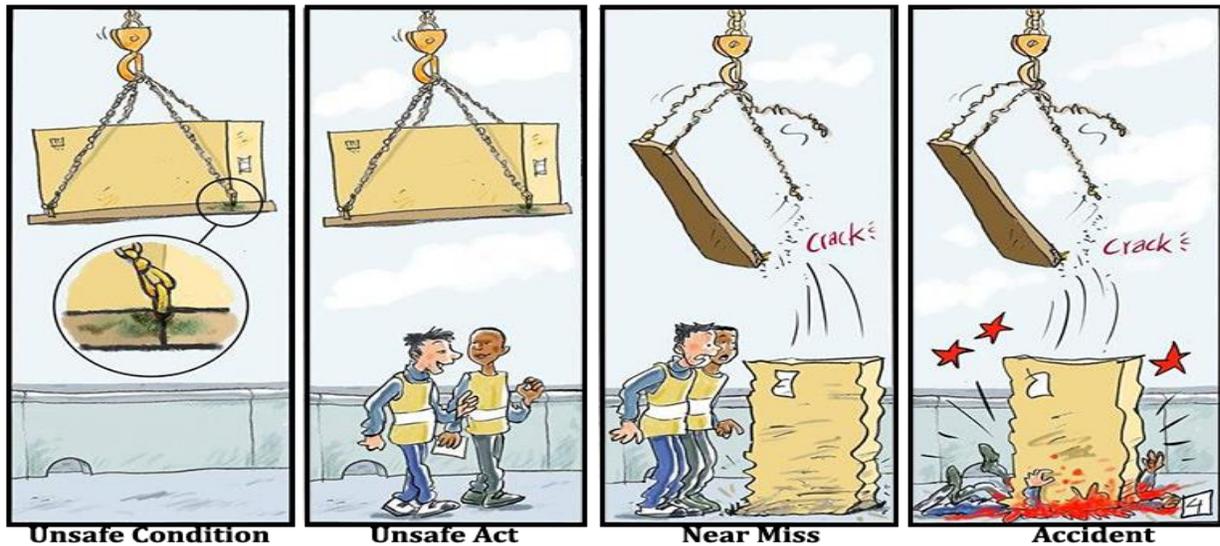
Following lacunae noted prior *commencement of dry survey of Block Panels:*

- *Wooden planks provided for working at height not properly secured*
- *No proper lighting provided inside the tank*

*In all instances attending surveyor had to wait for rectification of above safety issues before proceeding for inspection. Noted the lapses are of a recurrent nature at some yards.*

- ❖ It is advised to have regular meetings with Shipyard management to review safety procedures & appraise them of lapses in safety related matters to avoid any untoward incident.
- ❖ Surveyors to be always vigilant for unsafe acts/practices

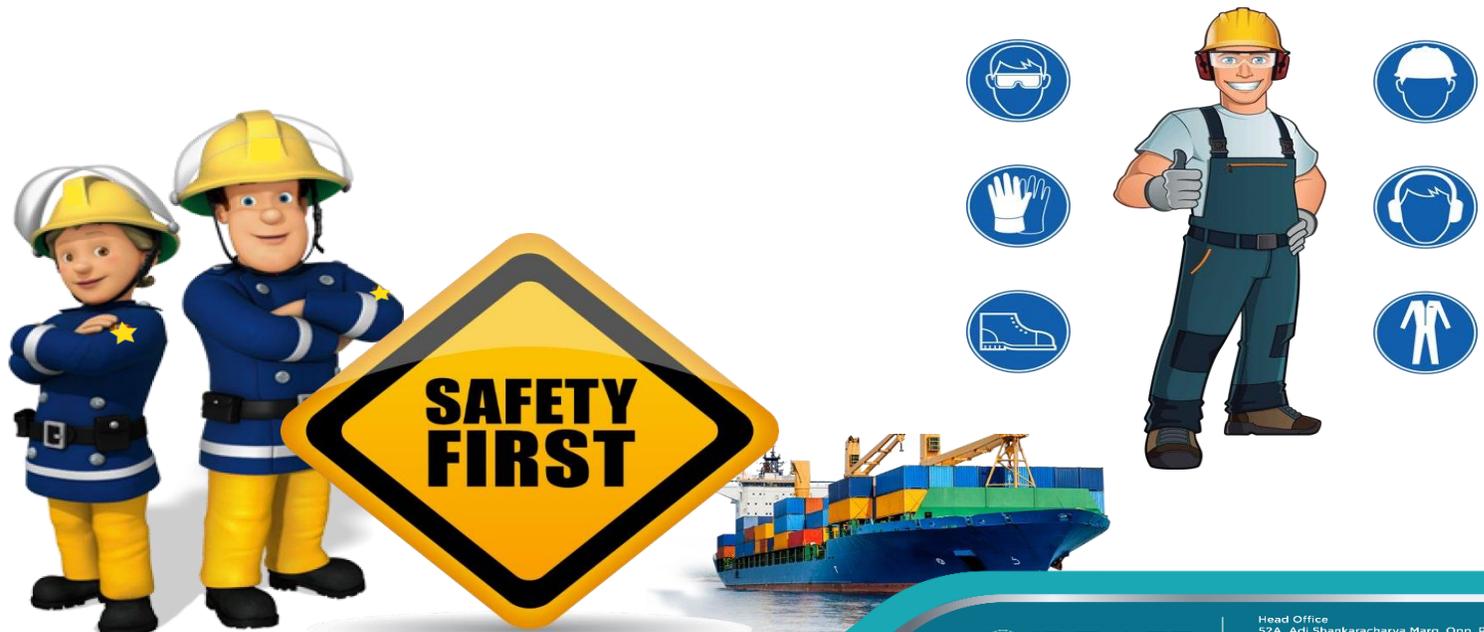
Following noted while taking round of engine room during survey attendance:

- *Engine room kept full of old/spare machinery.*
- *Floor plates found removed at various places.*
- *No safe access available for survey.*

- ❖ Surveyors should not inspect the engine room concurrently while walking.
- ❖ It is advised ship staff should be always available alongside when carrying out an inspection & lead to be taken by ship staff & surveyors to follow subsequently.
- ❖ Further it is advisable that Surveyors do not rush or walk fast & every care should be taken specially when the vessel is in dry dock and undergoing survey and repairs.
