Technical Circular

No.: 017/2025

Subject: U.S Coast Guard Safety alert on inadequate snap hooks on Marlin Australia lifejacket models 320RT & 321RT.

Safety Alert 11-25

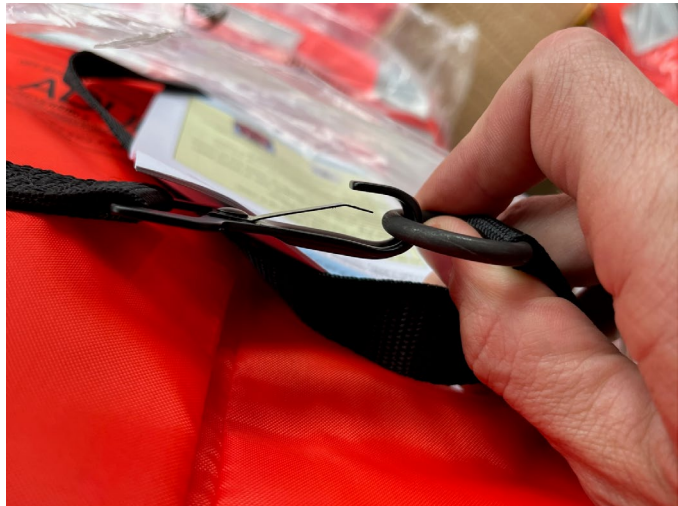
The issue involved a malfunctioning spring-loaded tab within the snap hook that is sewn into the waist belt of Marlin Australia PTY LTD lifejacket models 320RT (USCG approval number 160.055/215) and 321RT (USCG approval number 160.055/216). The spring-loaded tab within the snap hook mechanism failed to “spring back” or return to the closed position after depressing to secure the snap hook to the D-ring. Instead of fully closing once initially depressed, the spring-loaded tab returned to a partially closed position (approximately ½ to ¾ closed), which may allow the D-ring to slide out without additional manipulation of the clasp.

Example of a partially closed snap hook.

The Coast Guard **strongly recommends** that owners/operators that have Marlin Australia PTY LTD model 320RT or 321RT lifejackets onboard their vessels inspect them closely for this potential defect and if defects are found:

- contact Mr. John Murray Jr. of Marlin Australia PTY LTD by phone at +02 9557 3999 or email at JMurray.Jnr@carrycode.com.au for specific directions on how to rectify this issue; and
- contact CG-ENG-4 at TypeApproval@uscg.mil with the lot numbers from the affected lifejackets.

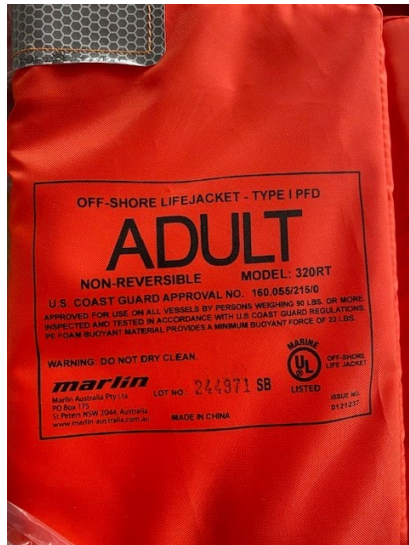
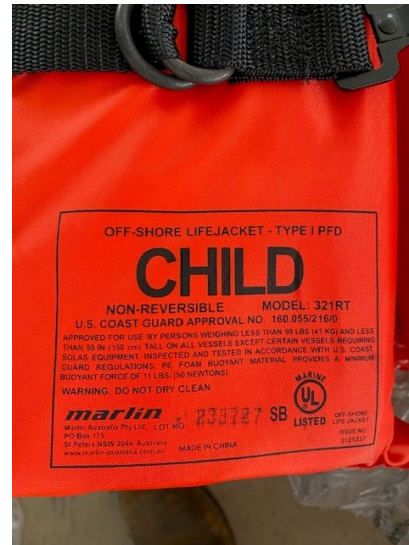
The images above show the defective models only, not the defective lot numbers.
