# Technical Circular

No.: 24/2025

**Subject: U.S Coast Guard Safety Alert addressing potential failures in high-pressure water mist nozzles due to corrosion.**

## **LOOKOUT FOR GREEN PATINA BUILD-UP ON HIGH PRESSURE WATER MIST NOZZLES**

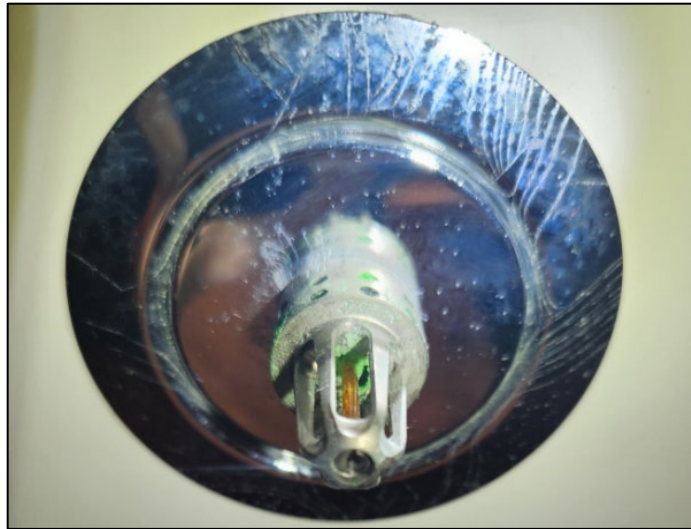
While witnessing routine testing of a fixed firefighting system during an annual exam aboard a foreign passenger vessel, the Coast Guard discovered multiple high-pressure water mist nozzles that were incapable of discharging water. Consequently, the firefighting system failed to activate in multiple accommodation spaces. Upon expanding the examination, Port State Control Officers determined that the high-pressure water mist nozzles in question were manufactured by Marioff (“a2000” series) as part of the “HI-FOG” system. The accumulation of green patina on the nozzles, a sign of corrosion, rendered them unable to release water after the glass bulb broke.

The high-pressure water mist nozzles are designed to hold the standard line pressure of 25 bars (363 PSI). When the glass bulb thermal actuator (shown in the photo above) reaches a certain temperature, it breaks, activating the release mechanism which allows water to flow through the nozzle at the standing pressure (International Maritime Organization [IMO] Resolution A.800(19)). The system then senses the drop in pressure and activates the high-pressure pumps which increases the pressure to 140 bars (2,031 PSI). This increased pressure is required for the system to achieve an effective release of water in a mist form.

- Contact the manufacturer if any signs of green patina build-up are observed on high-pressure water mist nozzles and consider replacing the affected nozzles.

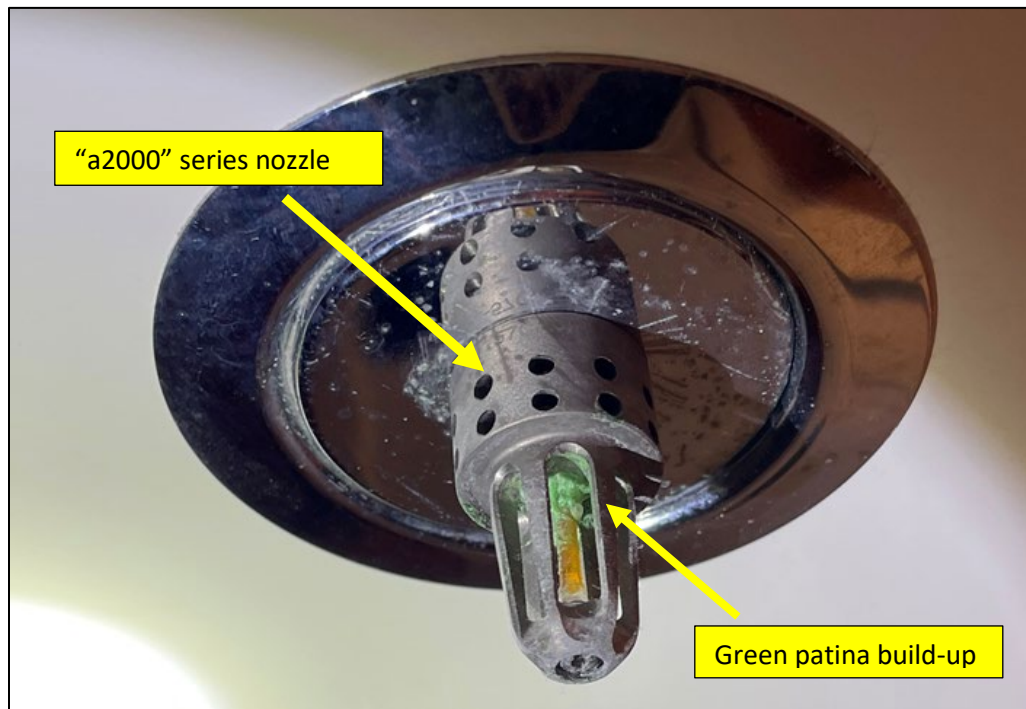
The manufacturer, Marioff, released a Service Bulletin (001/2012) and Quality Bulletin (002/2012), which originated due to failures of the “a1000” series nozzles. The bulletins describe the same failure as that noted on the “a2000” series during the recent examination and includes recommended actions that apply to both the “a1000” and “a2000” series nozzles. Marioff recommends that if a nozzle fails to release at the standing pressure of 25 bars after the glass bulb is broken, the high-pressure pumps must be manually energized to raise the pressure to 140 bars. Doing so will activate the release mechanism allowing water to flow through the nozzle. During the examination the Coast Guard witnessed this recommended action and observed that raising the pressure of the system to the recommended 140 bars did not activate the release mechanism of the nozzles as expected. Thus, in this case, the actions recommended by Marioff in Service Bulletin (001/2012) and Quality Bulletin (002/2012) did not raise the system pressure sufficiently to activate the release mechanisms for the nozzles.

- Conduct an inspection of all high-pressure water mist nozzles across the vessel to identify any potential issues and consider whether more frequent inspections are necessary. Sprinklers with the highest risk of corrosion include sprinklers more than 10 years old and those located in high moisture and corrosive atmospheres. Areas of high moisture could include outer decks, spas, pool areas, galleys, or even normal passenger and crew areas close to external doors. Review the manufacturer's service and quality bulletins for more information.
