Final report MO-2017-205: Multipurpose container vessel *Kokopo Chief*,
cargo hold fire, 23 September 2017

Marine inquiry MO-2017-205
Multipurpose container vessel *Kokopo Chief*

Cargo hold fire

23 September 2017

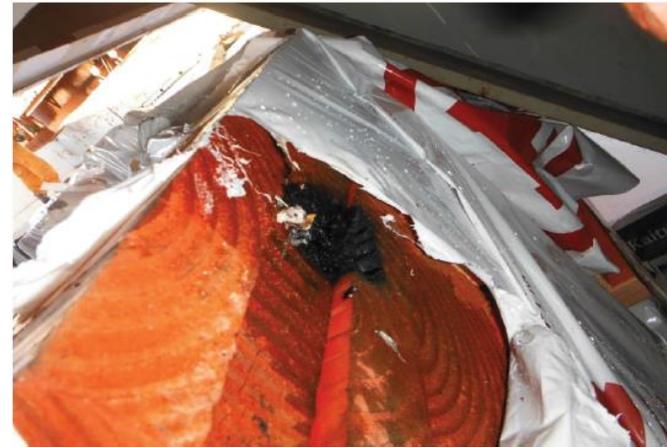
NEAR MISS – Timber pack got burnt under fixed cargo light.

While lashing some timber packs on #4(S)Tween Deck, stevedore noticed one timber pack, being close to halogen lamp emitting some smoke, and a smell of burnt timber was felt. A plastic cover of a timber pack shrunk & burnt due to its proximity to the cargo hold lamp. Two sawn timber planks sustained about 35 cm burn spot on their sides. Affected area was immediately flushed with water and observed for several minutes. Burn spot was removed. All lights were switched off in cargo holds and tween decks which contained timber.

- 1) Take a note of proximity of fixed lighting in cargo holds to stowed timber.
- 2) All deck officers to keep cargo lights off in holds contained timber when cargo operations are seized.
- 3) Circulate 4 box to share the near miss with other fleet.
