# **Technical Circular**

No.: 121/2017 Date: 25<sup>th</sup> September 2017

## **Subject: Fatal accident involving enclosed space entry.**

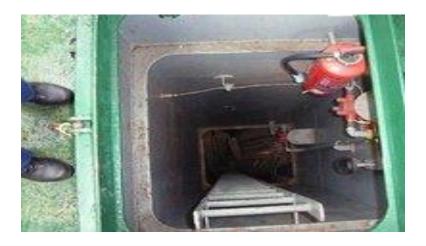
• As discharge of a cargo of coal progressed, the level in one of the cargo holds had lowered to the point where stevedores needed to enter for cargo trimming operations using bulldozers. The cargo hold ladders were completely enclosed within a trunk, with openings at the main deck and at the lower part of the hold only. In accordance with shipboard SMS procedures, it was necessary for the crew to arrange ventilation and testing of the trunk space atmosphere prior to permitting entry of personnel. The third officer instructed two crew members to open the cargo hold access hatch and install a ventilation fan at the entrance, a task which should not normally have required the crew to enter the hold. When the third officer arrived with the portable gas instrument, he saw the hatch open but the fan was not running. He then noticed that both crew members were lying unconscious on the hold ladder platforms within the trunk. The alarm was raised and rescue of the crew members was performed using self-contained breathing apparatus. Unfortunately, one crew member died and the other, although resuscitated, suffered the debilitating health effects of gas poisoning and oxygen starvation.

- ➤ All crew should be properly trained to recognise the hazards presented by the enclosed spaces on board and in safe entry procedures as per SOLAS requirements and IMO recommendations.
- ➤ Ship managers, Masters and crew must have a zero tolerance attitude to unplanned entry into enclosed spaces or breach of SMS procedures.
- ➤ Cargo holds are some of the most dangerous spaces on board vessels and should always be assumed to be dangerous until proven otherwise.
- ➤ Enclosed space openings need to be rigorously controlled. Cargo hold access hatches should be clearly labelled with warning notices prohibiting entry without an enclosed space permit.
