## **MARINE SAFETY ALERT**

Safety Alert 07-16

### **STEM TO STERN, FOAM TO DUST INSPECTING YOUR LIFEJACKETS IS A MUST!**

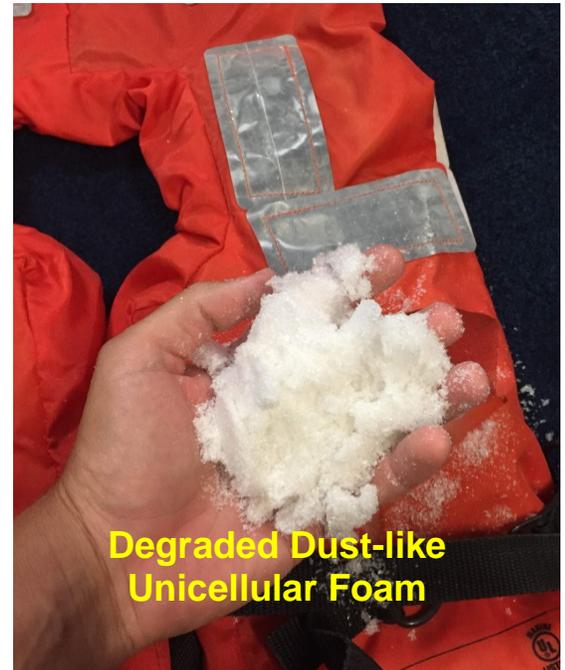
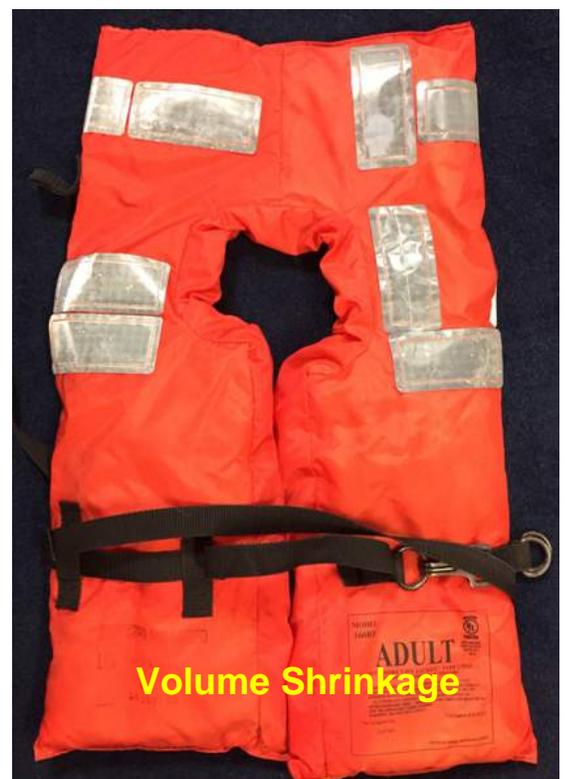
This safety alert reminds all vessel operators to routinely inspect their lifejackets to ensure they are suitable for service. Recently Coast Guard inspectors in Key West, Florida discovered two vessels that had over 60 lifejackets that were required to be removed and destroyed. It was discovered that the unicellular foam buoyant material within the nylon outer shell had degraded significantly over time, broke apart, crumbled and in some instances was reduced to dust. The lifejackets were properly stored, kept dry, and not under direct sunlight; however, the location was very hot at times.

These particular lifejackets were the Type 1, 160RT model distributed by "The Safeguard Corporation" of Covington, Kentucky. They were manufactured in China and approximately nine years old. The distributor is no longer in business. Over the years, the Coast Guard has distributed a number of other safety alerts related to lifejackets and personal flotation devices (PFDs). The archive of alerts can be accessed at the following site: [http://www.uscg.mil/hq/cg5/cg545/alerts/96\\_14SA.pdf](http://www.uscg.mil/hq/cg5/cg545/alerts/96_14SA.pdf). See PDF page numbers 27, 72, 138, 145, 158 and 165.

As a result of this recent discovery the Coast Guard **strongly recommends** that vessel owners and operators inspect their Type 1 unicellular plastic foam lifejackets for potential indications of failure or degradation, specifically:

- Compression: The lifejacket may be compressed from many years of stowage.
- Loss of resiliency: The lifejacket is excessively hard, stiff or its foam is brittle. Normally after compressing the lifejacket to about half its initial thickness, the foam should expand to its original dimension in a short period of time.
- Shrinkage: A physical reduction in size may be indicated by "wrinkling" of the coating on vinyl dipped type or by a loose fitting shell on a fabric-covered lifejacket.
- Manufacturer: While the potential for problems applies to all older PFDs, those manufactured by "The Safeguard Corporation" should be closely examined.
